**COST Action C17: “Built Heritage: Fire Loss to Historic Buildings”
International Workshop, Santa Maria della Scala, Siena, Italy: 7 - 8th April 2005**

Summary Report

International Workshop Associated Introductory Papers

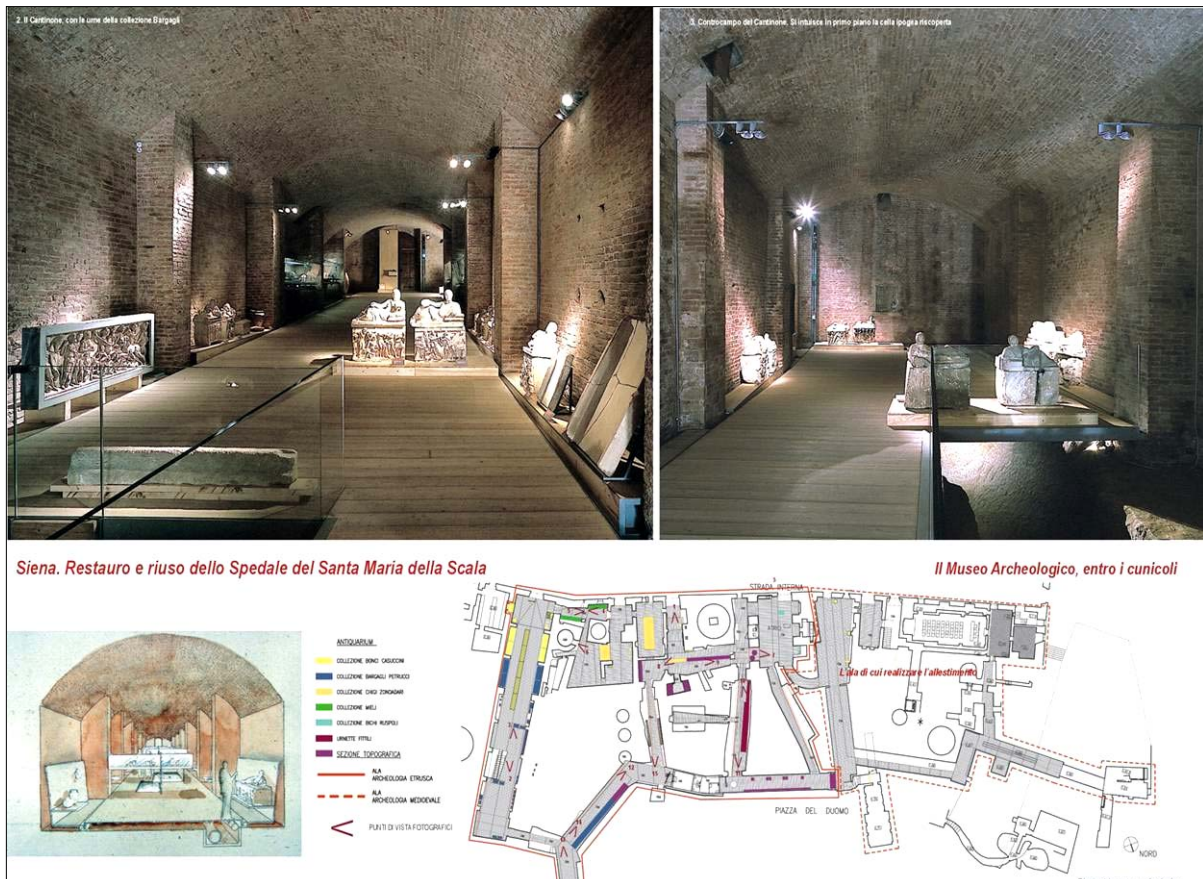
Basement level details of Santa Maria della Scala, Siena (*Guido Canali, Architect*)

A variety of technical solutions were illustrated such as a brick faced door and “totem” service pillars on top of a floating timber floor, with sub-floor services – although this approach still cause concern about flame spread below the floor panels.

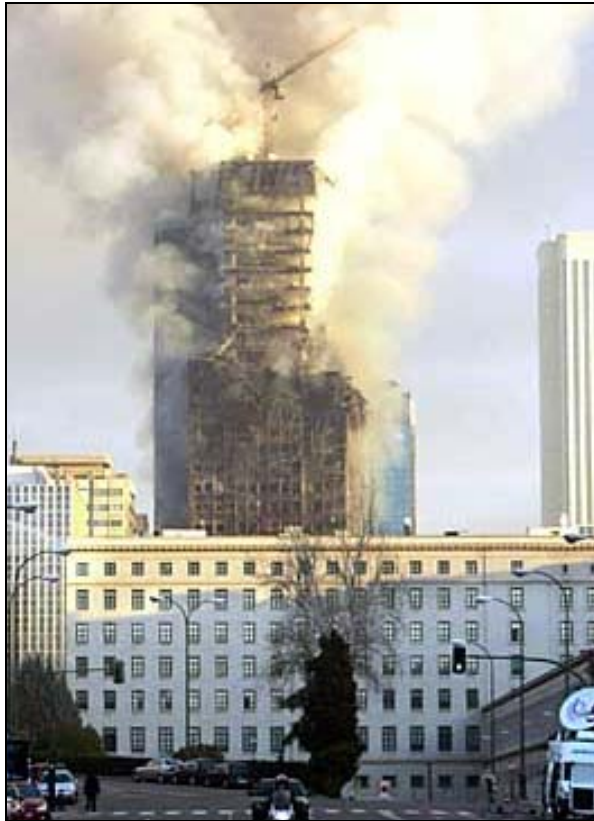
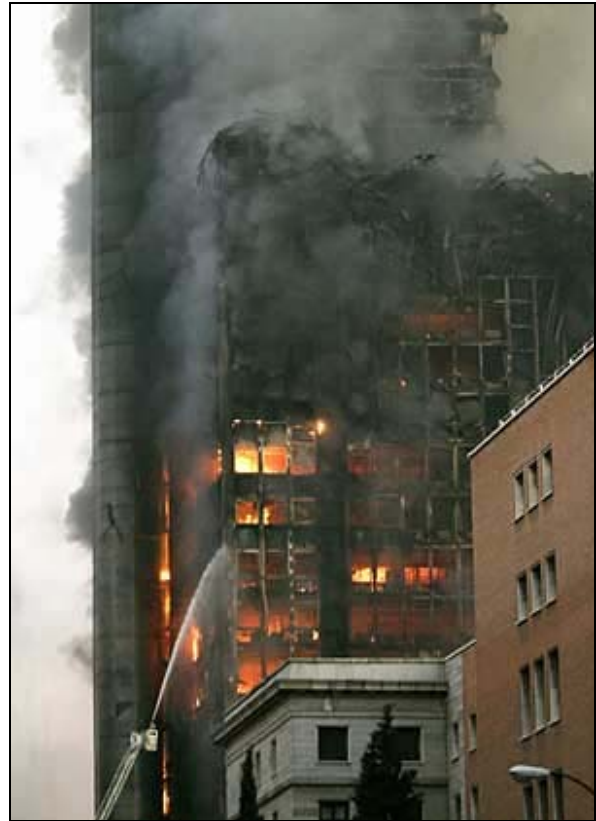
Windsor Building during the fire

- The fast propagation of fire in the upper section of the building lead to the breaking of the curtain wall and strongly damaged metallic columns in the facades, causing their deformation and collapse.

- Some bays adjacent to the facades in the lower section of the building were in very bad conditions and risked to collapse. Steel columns were strongly deformed due to a long and direct exposure to fire.

- The debris accumulated on the upper technical floor.
- Metallic frames hang over the perimeter.
- Next floors and concrete columns parallel to north facade had also collapsed over the technical floor.

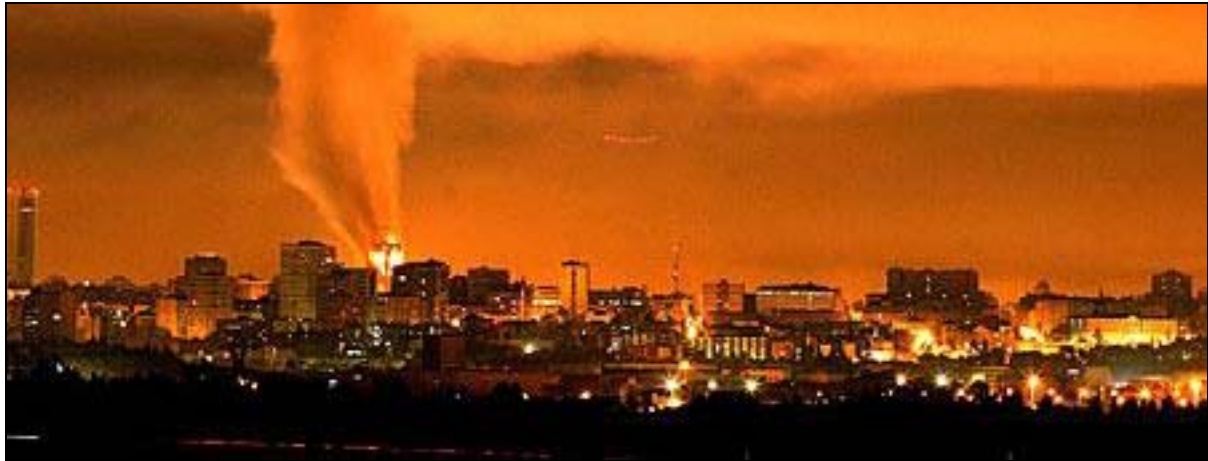
Windsor Building during the fire
