Riksantikvaren - The Norwegian
Directorate for Cultural Heritage (RNDCH)

Analysis of Sprinkler Failures in Listed Heritage Buildings

Analysis of unintended activations of water
based extinguishing systems in Norwegian
heritage buildings

Report no. 1
Issue no. A
Date of issue 10. February 2006

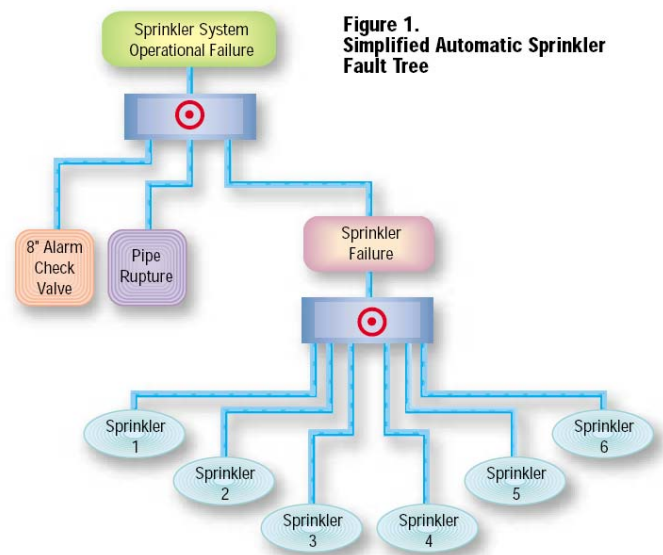
SFPE offer a systematic approach for calculating reliability of sprinklers, and include the very simplified illustration at right.

Figure 1. Simplified Automatic Sprinkler Fault Tree
